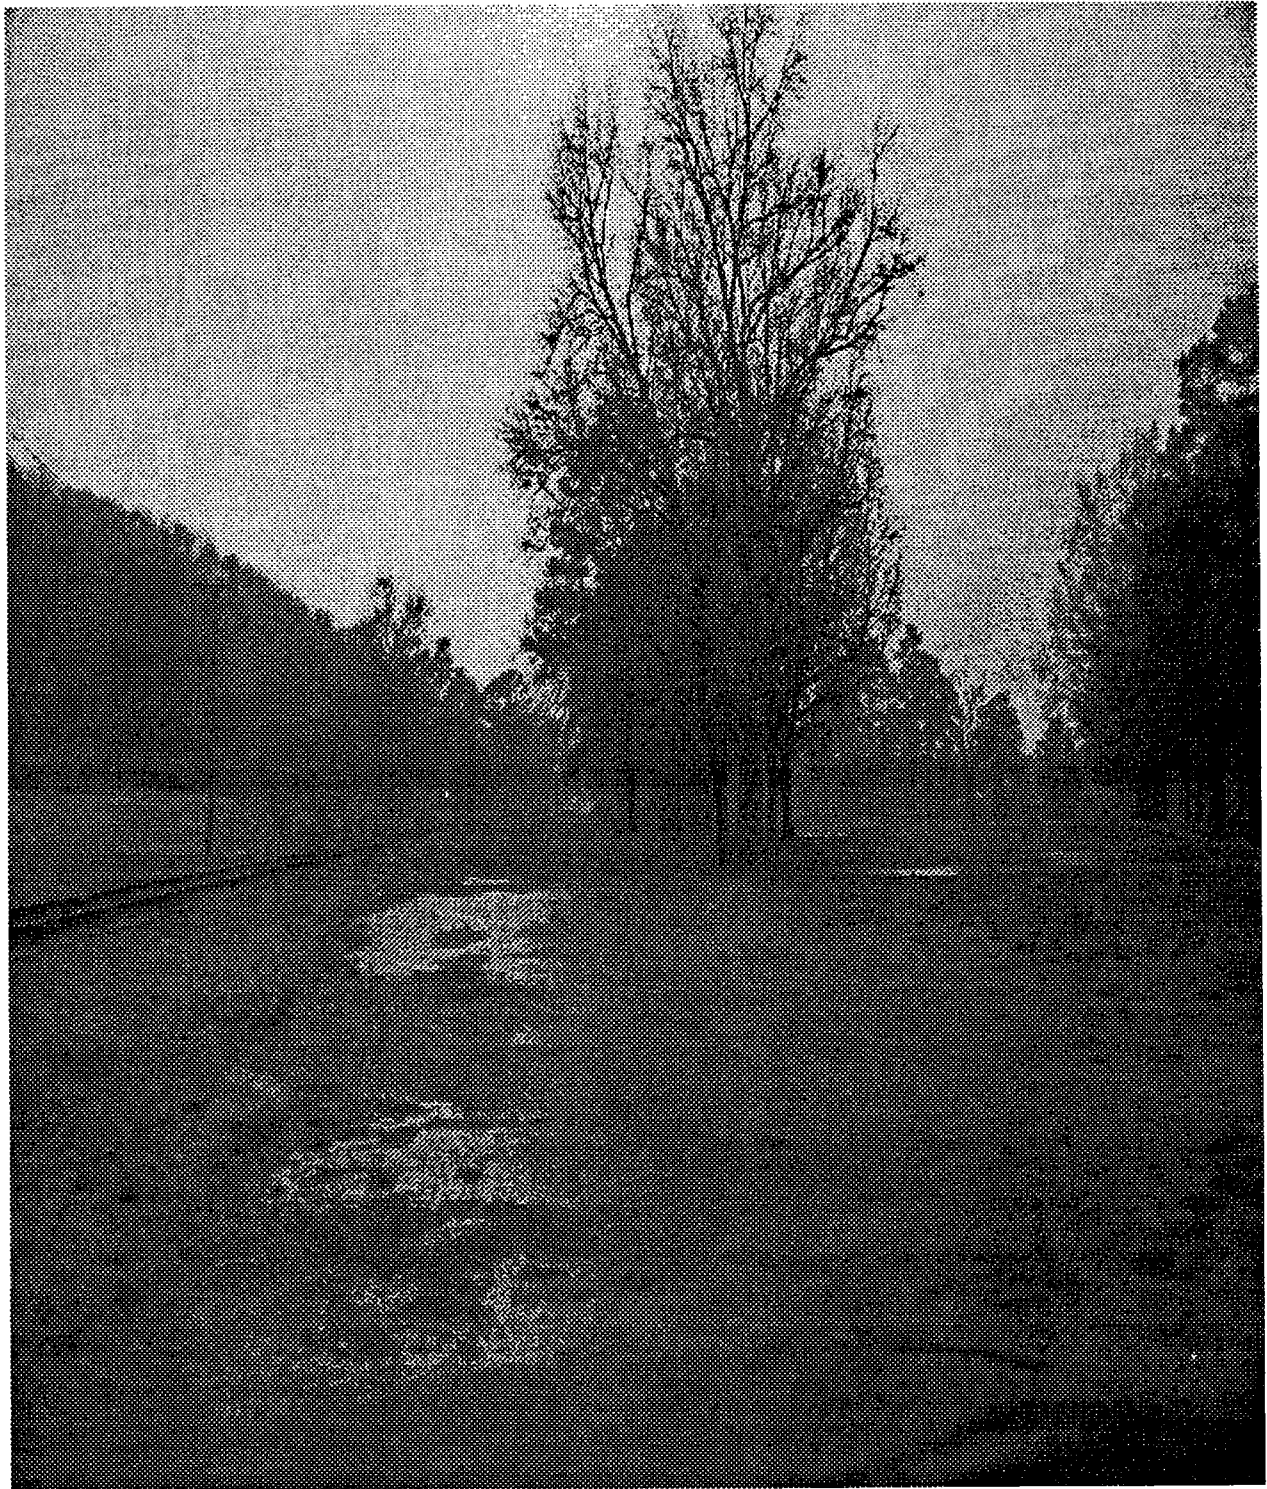
Photo E11 [3/5/98-11:12]

Former Pesticide Storage and Mixing building; Site 141(7) [CERFA Parcel Map 12,36]

Site 141(7) is currently part of the golf course. The site is now an open area with a small foundation in the ground between a small stand of trees and the railroad tracks directly across the street from Bogie's Clubhouse. The photograph (shot to the NW) depicts standing water on the site due to a storm event. There are stands of trees scattered around the area and a maintained lawn covers the area (i.e., golf course).

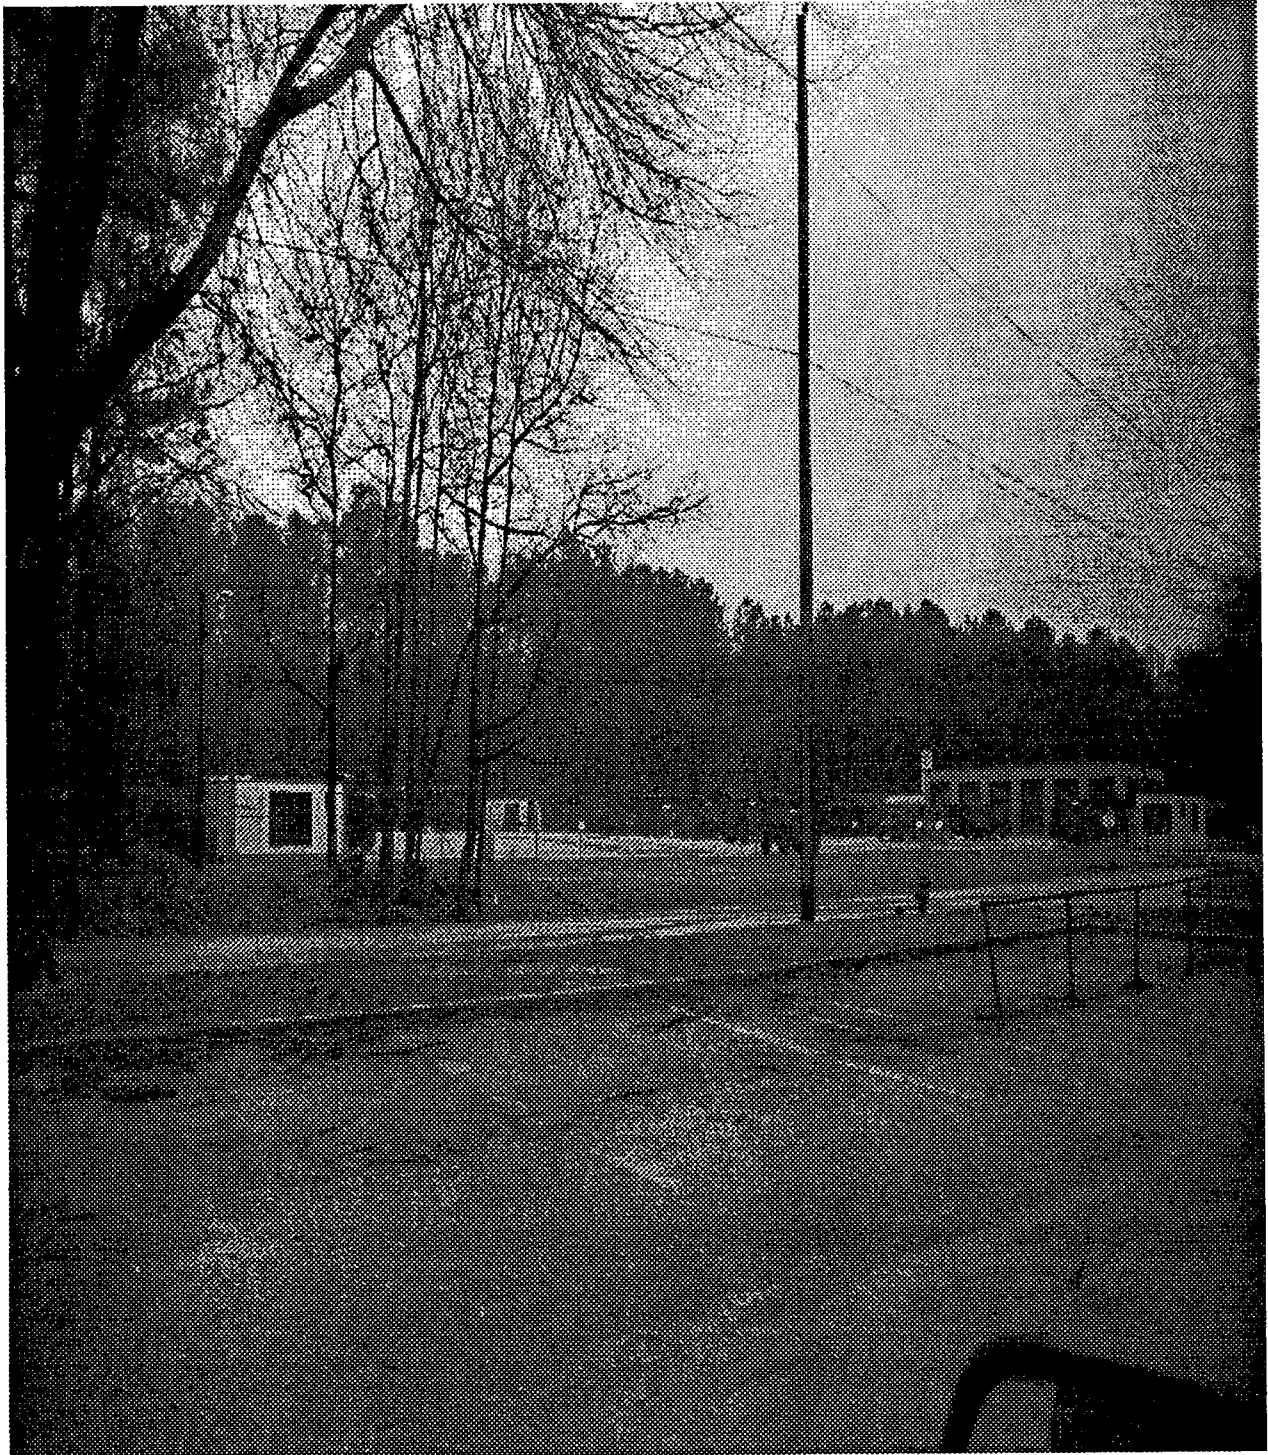
Photo E12 [3/5/98-11:29]

Motor Pool Area 3100, Site 147(7) [CERFA Parcel Map 11,27]

This site is located just south of 23rd road, it is currently inactive. Washracks, an oil/water separator, facilities for large vehicle maintenance, fuel pumps, and a vehicle loading ramp are located here. This site is also associated with sites 27(7), 28(7), and 72(7), these sites are located on the grounds of the Motor Pool Area 3100. The photograph (shot in the SW direction) depicts the motor pool area with large paved parking lot, garages/buildings, and military vehicles. Behind the motor pool is a very densely wooded area. There are drainage ditches all around the site.

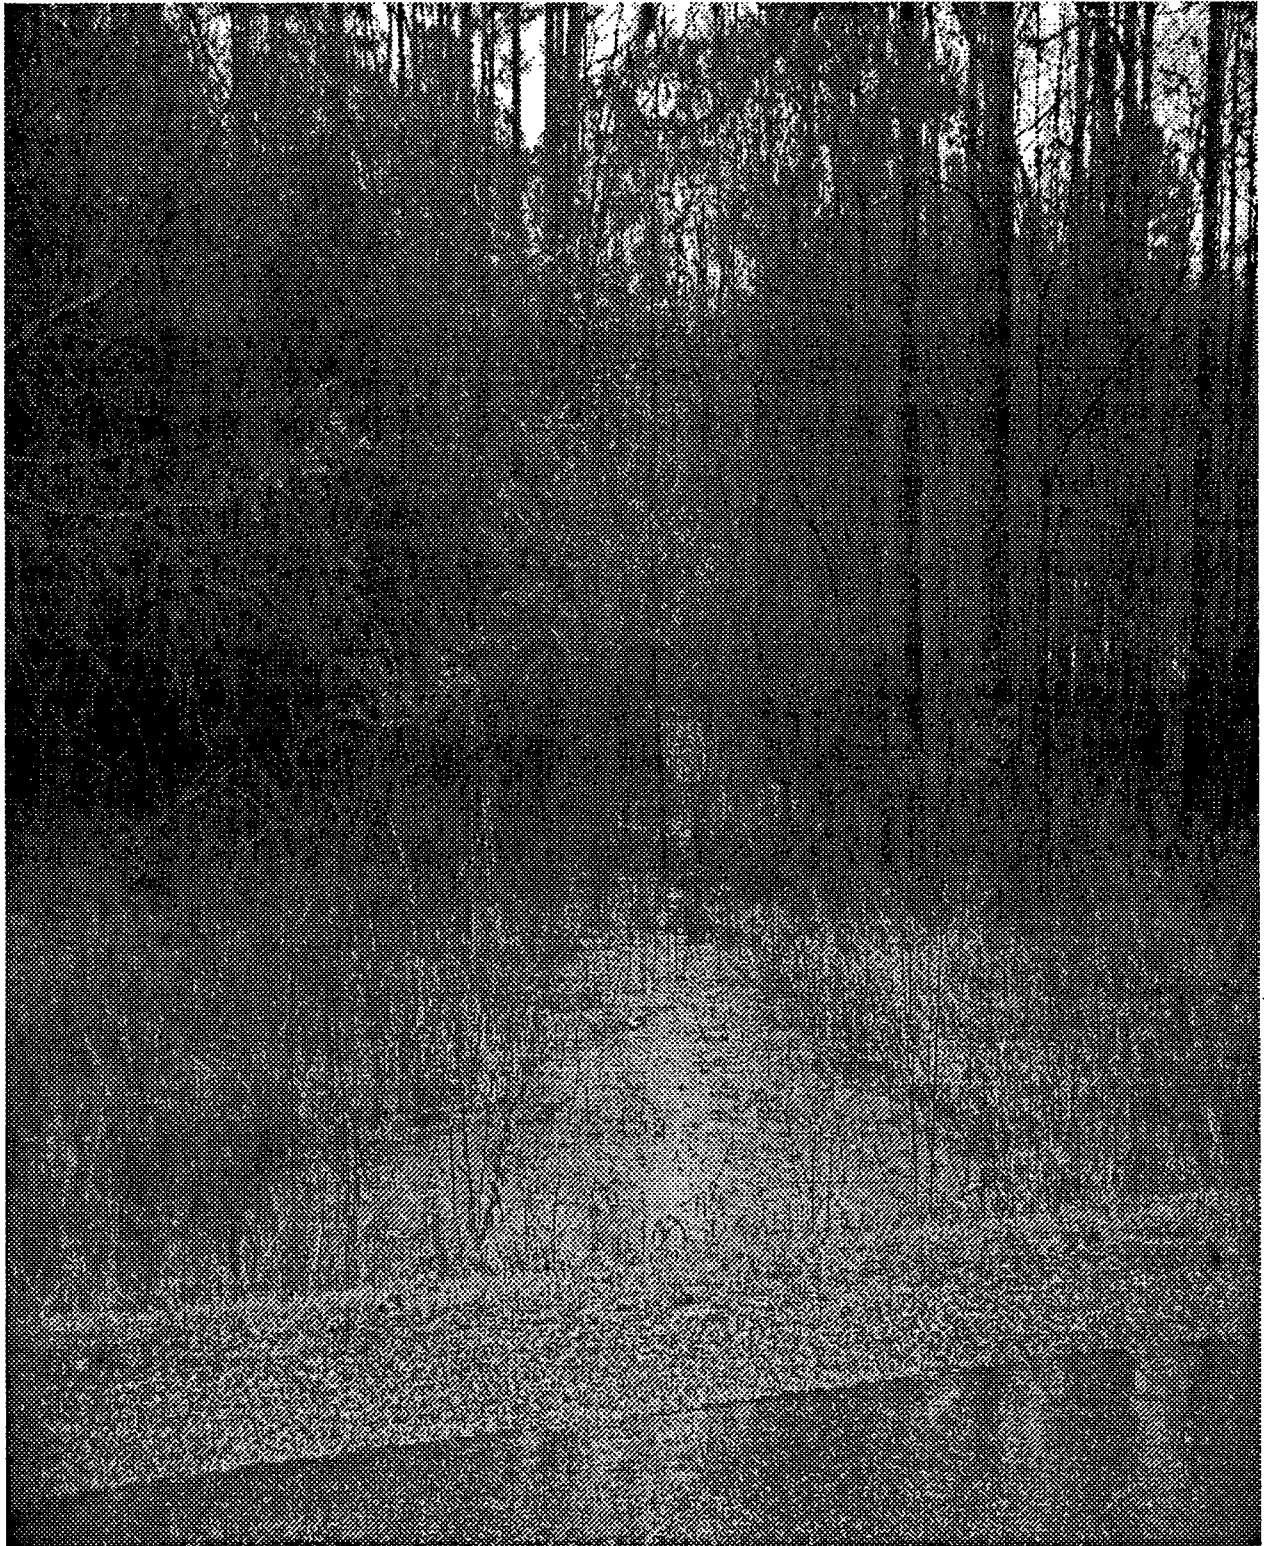
Photo E13 [3/5/98-11:33]

Former Fog Oil Storage Area, Site 122(7)[CERFA Parcel Map 10,26]

This photograph (shot to the east) depicts a stream/tributary flowing from fog oil area under road toward site 147(7). The area is heavily wooded.

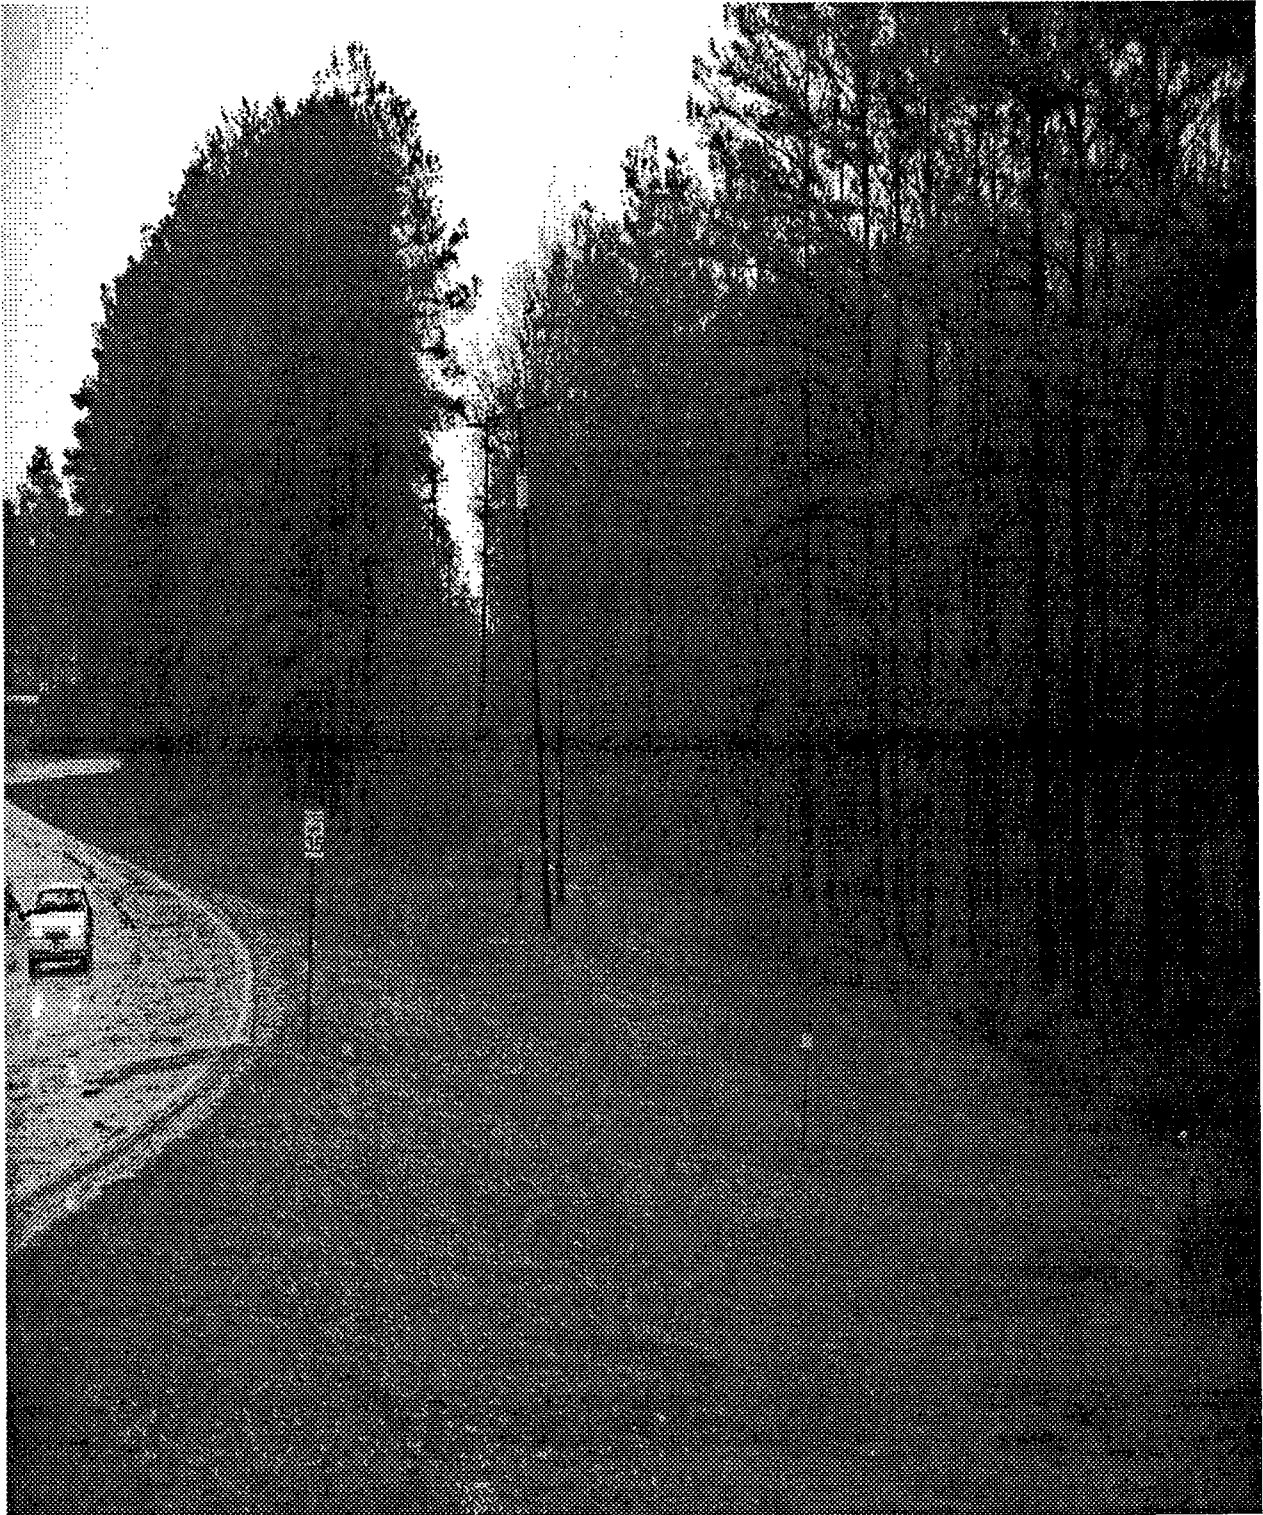
Photo E14 [3/5/98-11:39]

Area 45, Site 232Q [CERFA Parcel Map 5,24]

This site is adjacent to Summerall Road to the south. The photograph depicts a heavily forested area with stands of pine trees. There is a strip of maintained lawn pictured which provides a pathway for the power lines. Summerall Road is pictured in the far left of the photograph.

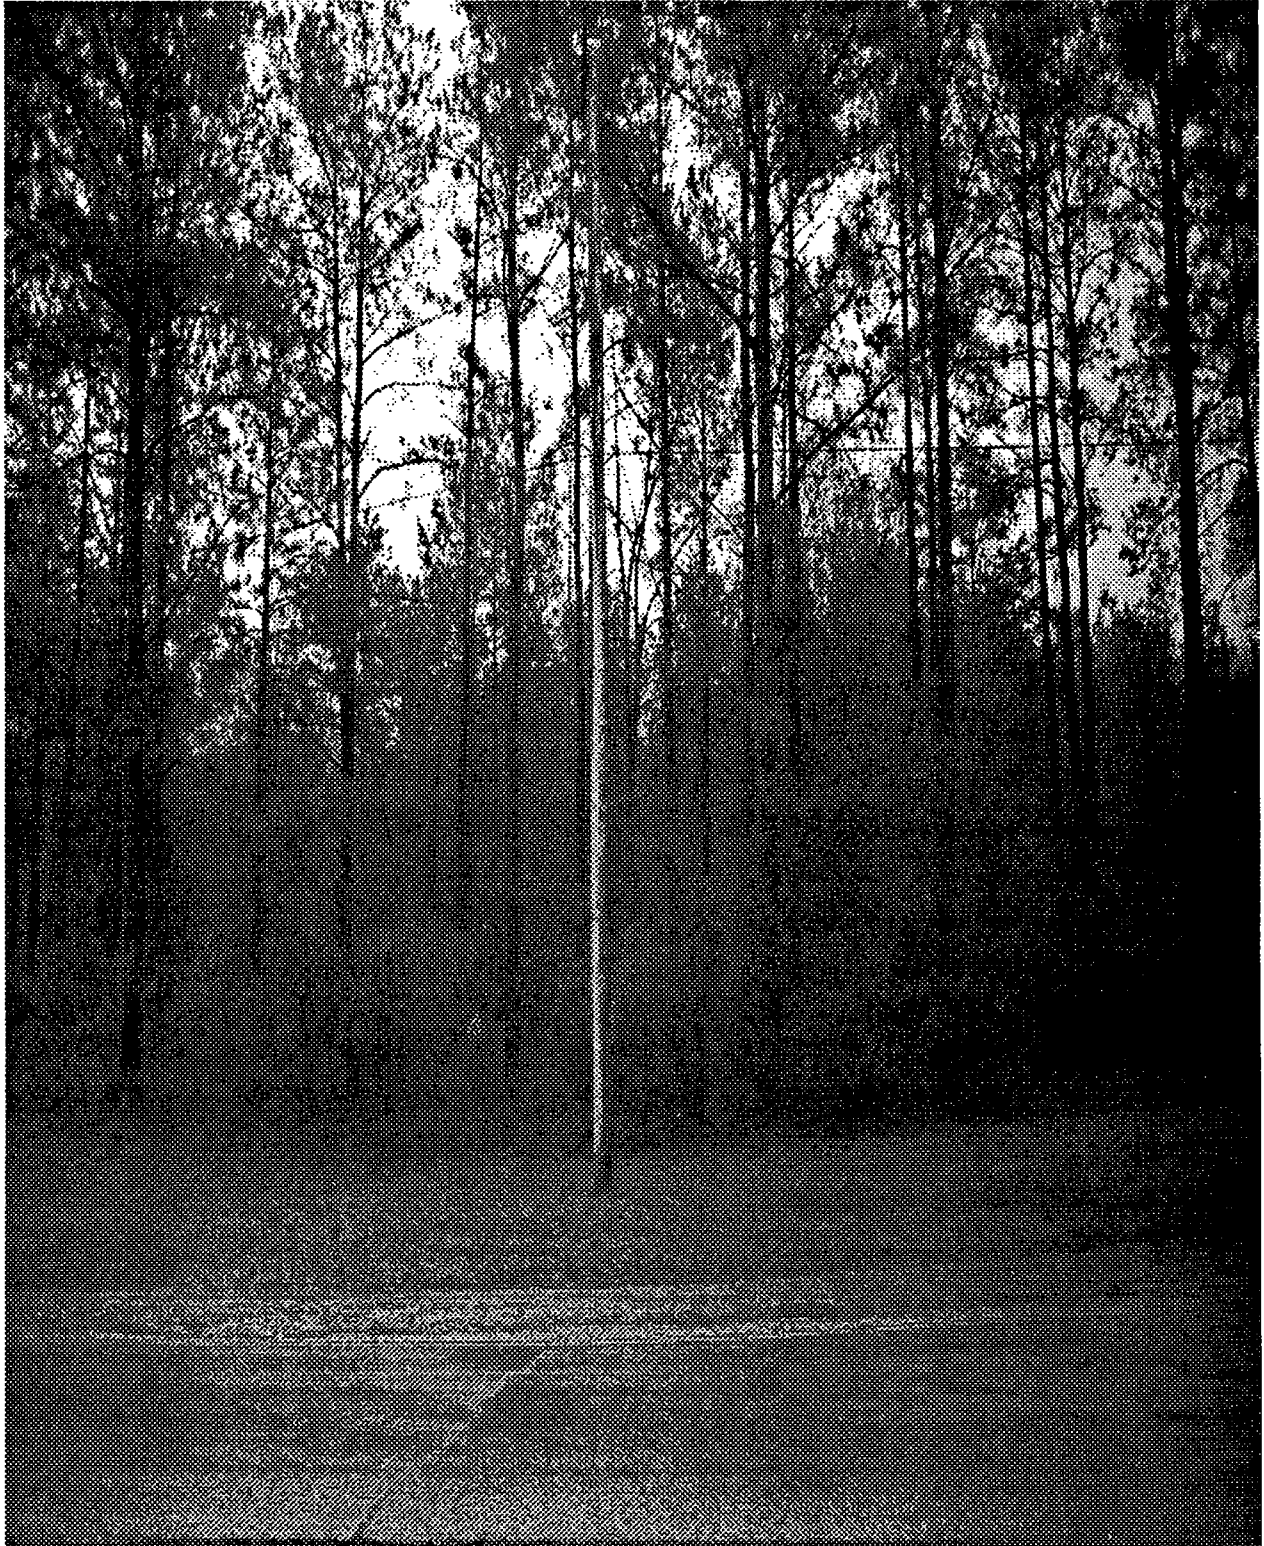
Photo E15 [3/5/98-11:42]

Former Transformer on Pole, Site 57Q [CERFA Parcel Map 3,27]

This site is situated adjacent to Summerall Road to the south. The area is heavily forested. There is a strip of maintained lawn pictured which provides a pathway for the power lines.

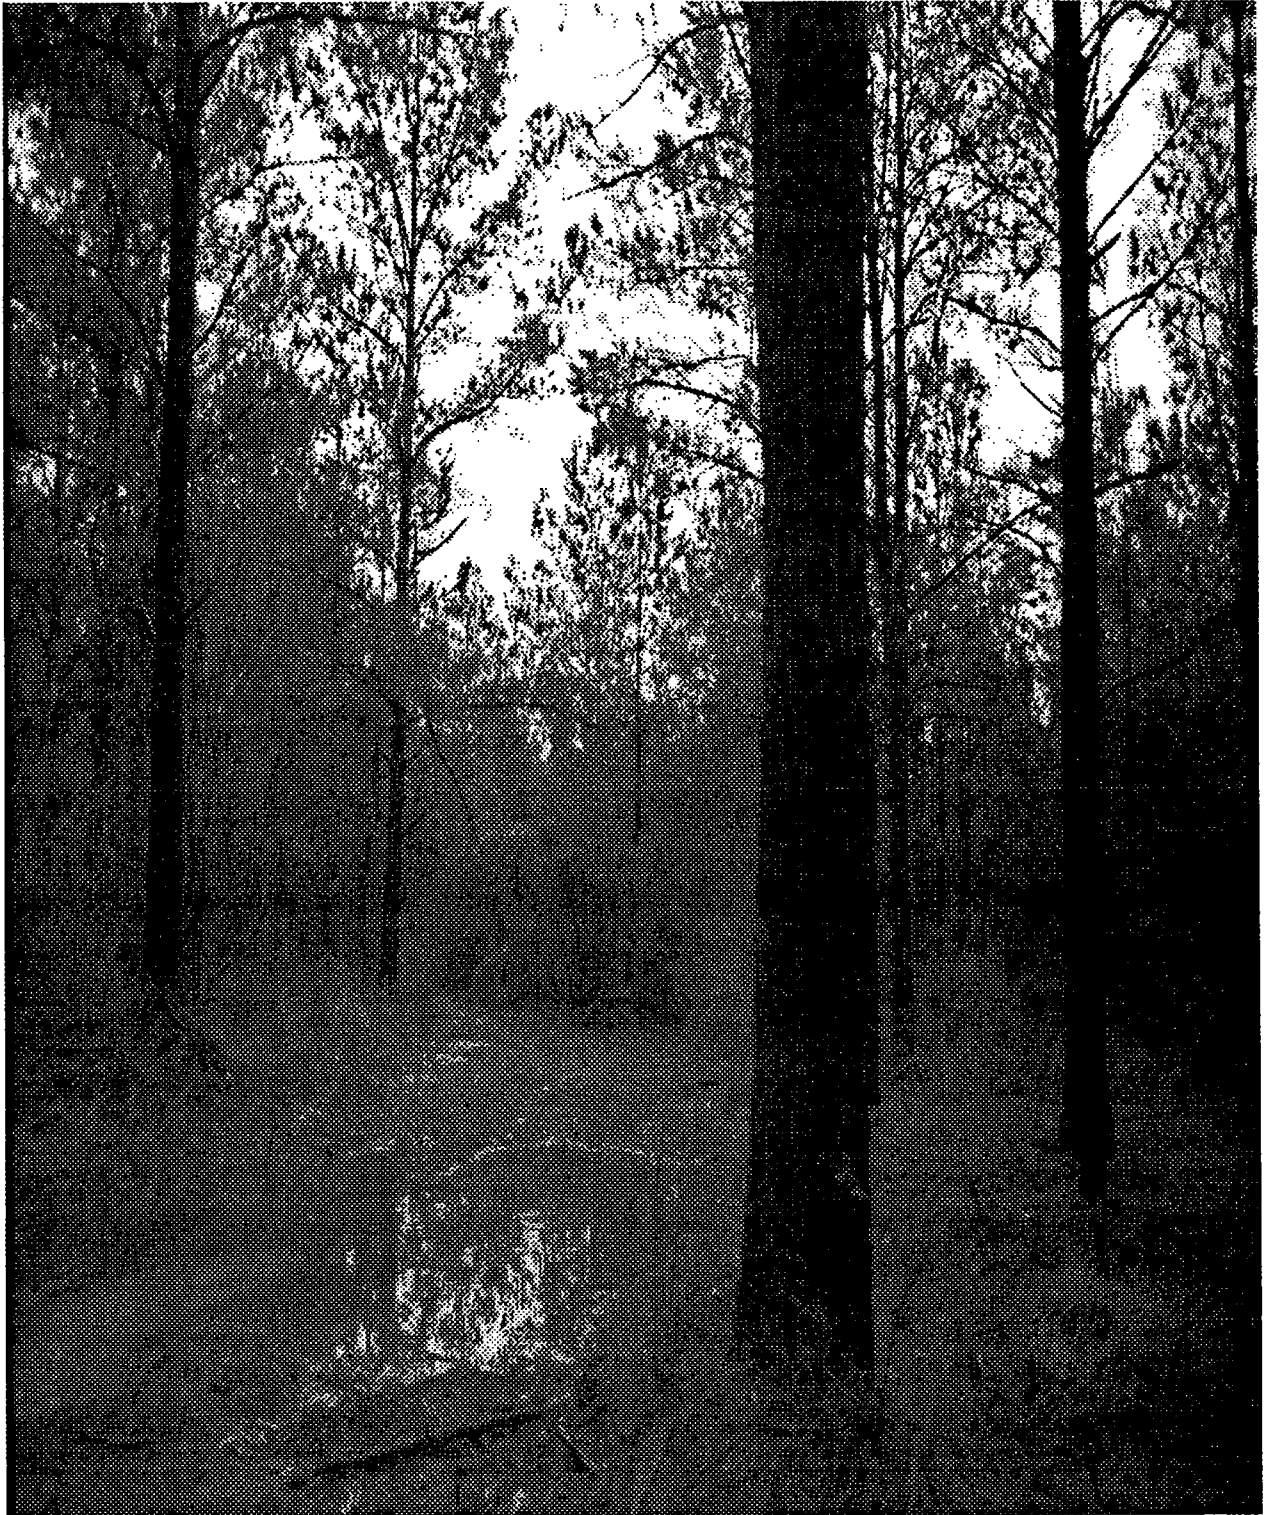
Photo E16 [3/5/98-1:05]

Former weapons demo area, Site 194(7) [CERFA Parcel Map 4,23]

This site is a dense pine forest. The photograph (shot to the east) shows a dirt road that goes through the property. There was no obvious evidence of any aquatic systems. The pool of water seen in the photograph is the result of heavy rainfall collecting in a small depression (rut) in the dirt road.

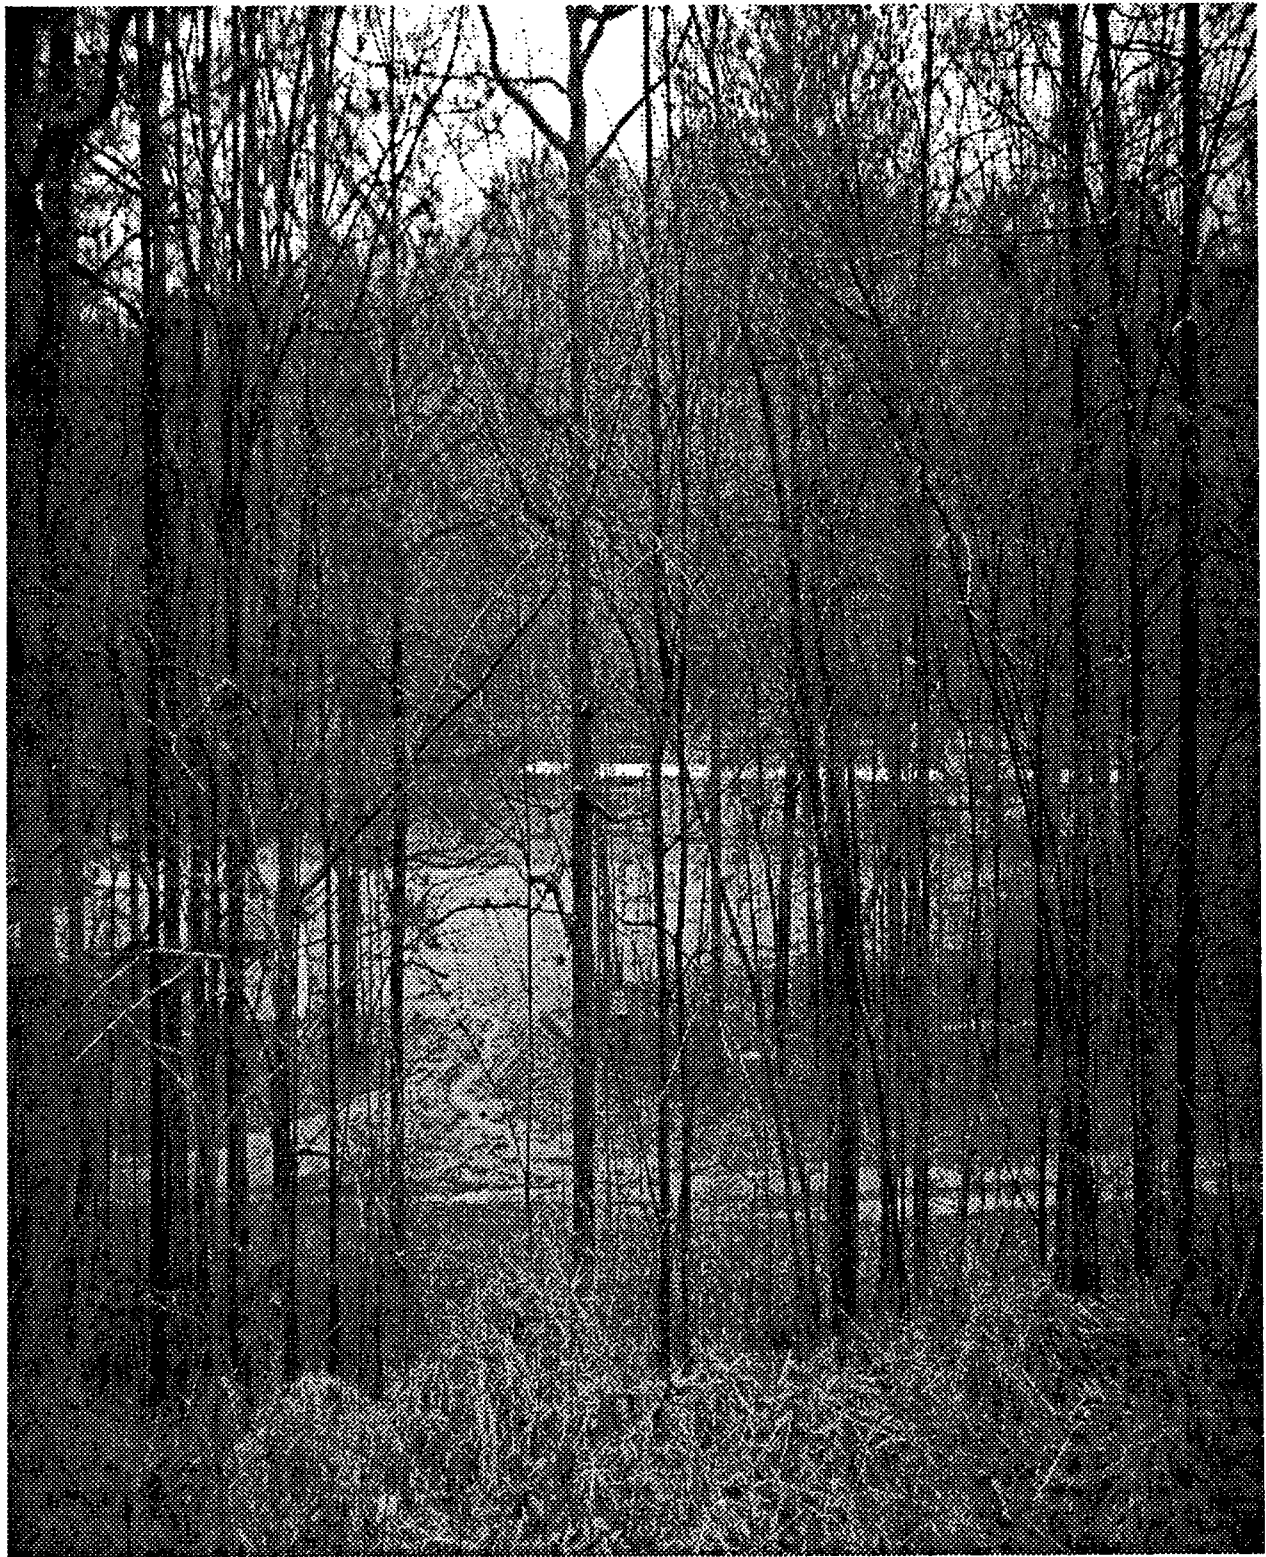
Photo E17 [3/5/98-1:17]

AST located at Range 13, Site 176(7) or 71Q [CERFA Parcel Map 10,21]

Range 13 (weapons training area) site 176(7) is located on the Southwest Main Post. The site is an open area against a backstop hill. Possible groundwater seeps from hill. The Range is surrounded by pine forest. The photo faces South toward the parking area. A site walk was not performed due to restricted access.

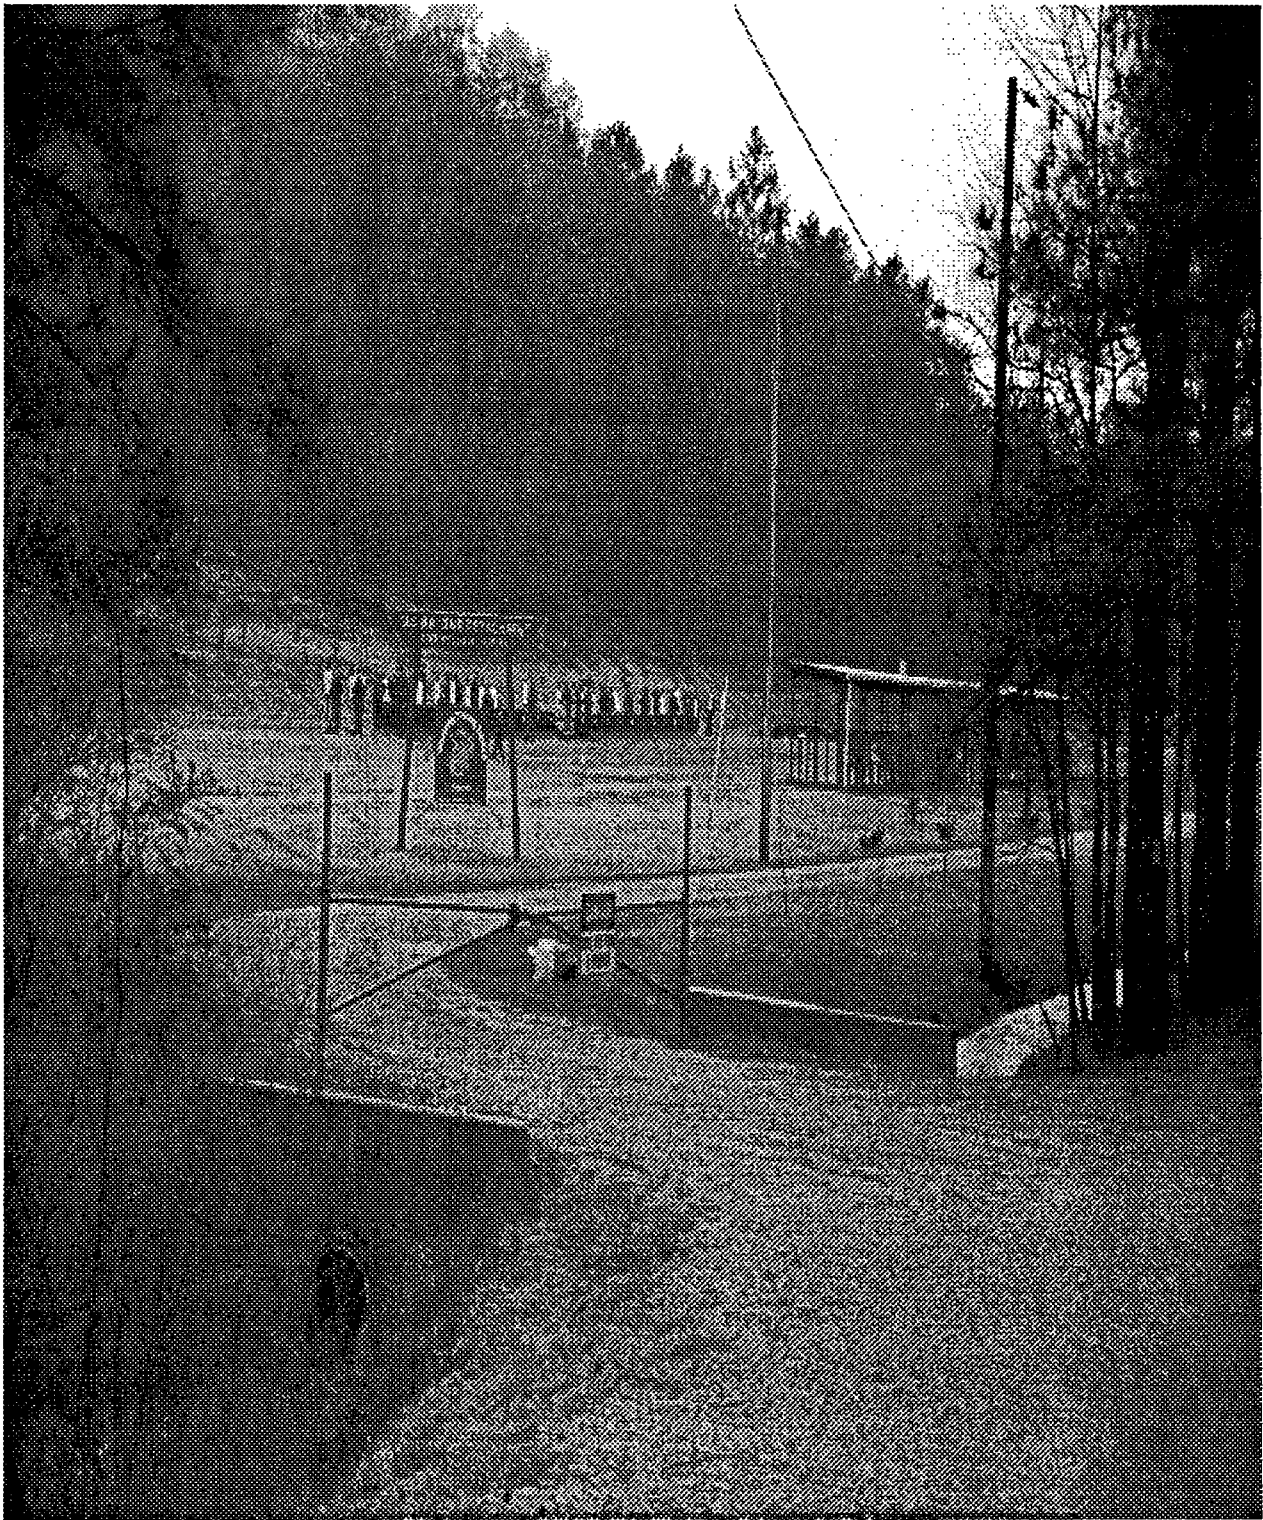
Photo E18 [3/5/98-1:20]

Another view of Range 13 site 176(7) or [71Q] [CERFA Parcel Map 10,21]

Range 13 (weapons training area) site 176(7) is located on the Southwest Main Post. The site is an open area against a backstop hill. Possible groundwater seeps from hill. The Range is surrounded by pine forest. The photo faces South toward the parking area. A site walk was not performed due to restricted access.
